Report No. UT-03.01

**UTAH ROCKFALL
HAZARDS INVENTORY
Phase I**

**Utah Department of Transportation
Research Division**

April 2002

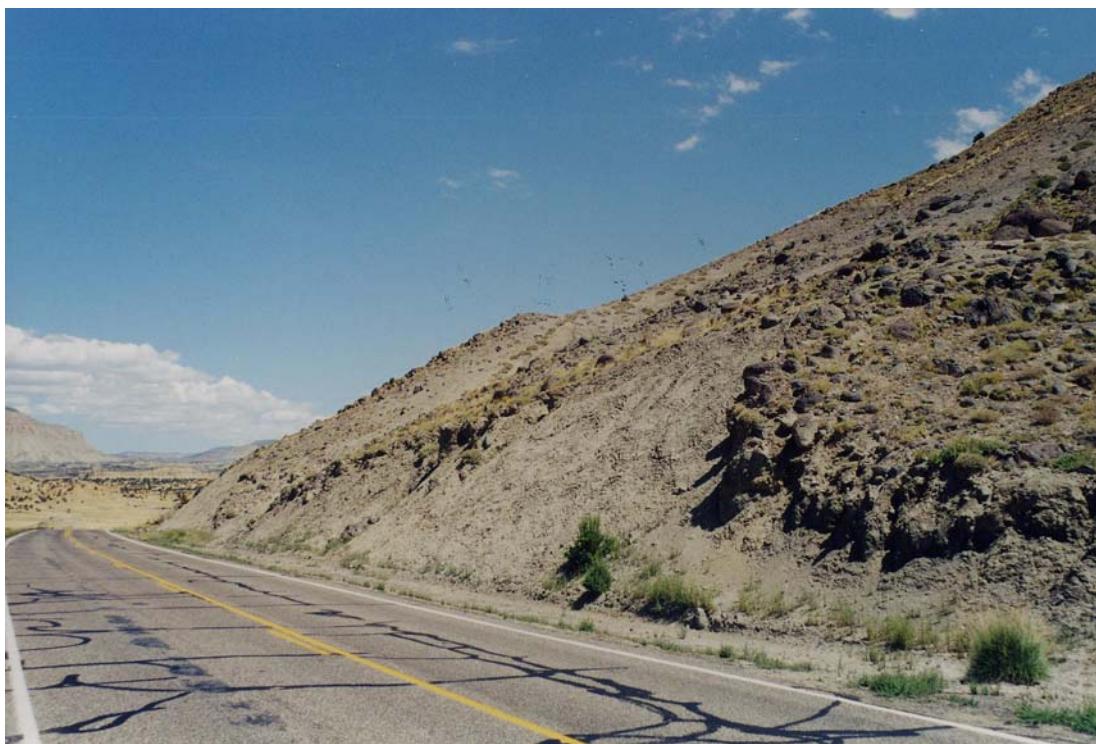
Figures 3 through 6 are photographs of representative slopes in categories A through C. The C slope given in Figure 3 is located in the jurisdiction of the Emery Maintenance Station in central Utah. The slope angle for this site is relatively low and is cut through a sedimentary rock unit (shale or mudstone) that is subject to moderate weathering. The upslope portion of this rockfall site has evident rounded boulders likely from an upslope alluvial or conglomerate source. The lower portion of the slope poses no risk to the roadway, save for small soft sediment sloughs where the upslope material might represent a low risk. However, because of the large roadside ditch and the low slope angle, this slope was given a C rating.

Figure 3. C-rated slope near Emery, Utah.

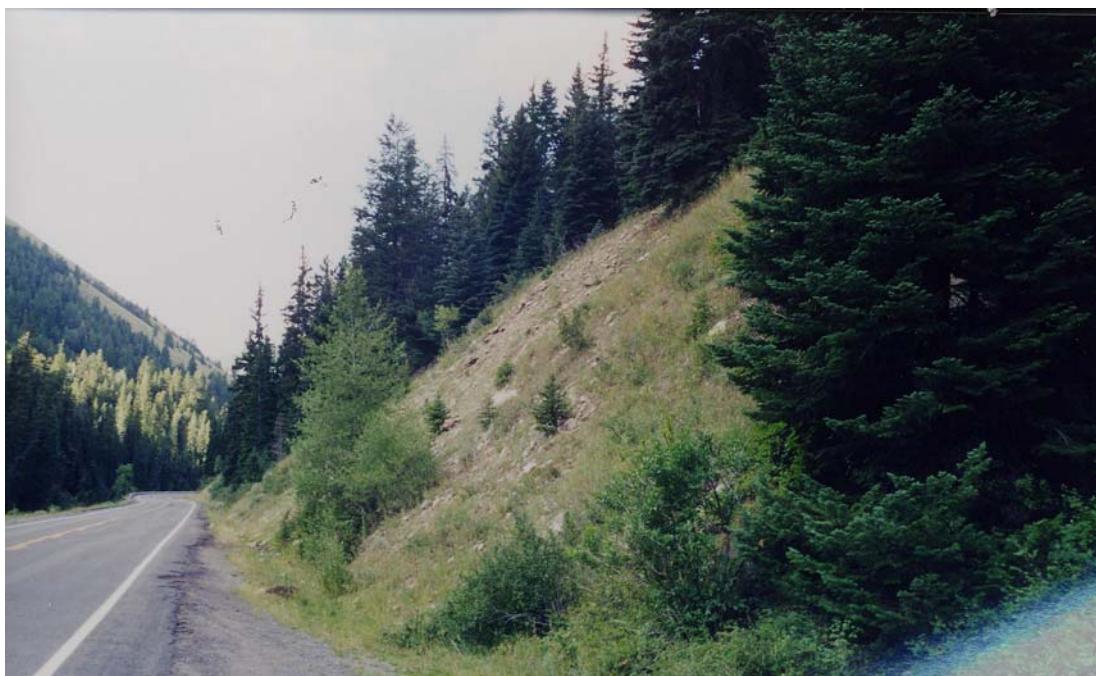
Two B-rated slopes have been included as examples. Figure 4 is from the Huntington Maintenance Station located in the Uinta Mountains while Figure 5 is from the Colton Maintenance Station. These two photos were chosen because they illustrate two very different B-rated slopes. The site in Figure 4 is what might be envisioned as a typical B slope. This cut is surrounded by heavy forest and has abundant plant cover on the slope itself. The presence of rock slabs on the slope surface indicates some possibility for rock sliding despite the plant cover and relatively low slope angle. In the background, it is apparent that there is a relatively modest berm area. This slope was given a B rating because of the small ditch/ berm area combined with the presence of slabs that could potentially slide on the slope face and reach the roadway. Figure 5 also shows a B-rated slope. This slope has both vertical and laid-back rock faces cut through multiple sedimentary rock-types. Differential weathering is apparent in two of the three layers shown. On first glance, this slope might seem to warrant an A rating but on closer inspection, the width of the ditch area indicates very effective catchments for debris (both slough and boulders evident in the ditch). This is also borne out by the modest amount of rockfall reported on the road over the years. This slope demonstrates the effect of well sized catchments on this preliminary rating system. This slope may have significant cleaning requirements to maintain its B status.

Figure 4. B-rated slope near Huntington, Utah.

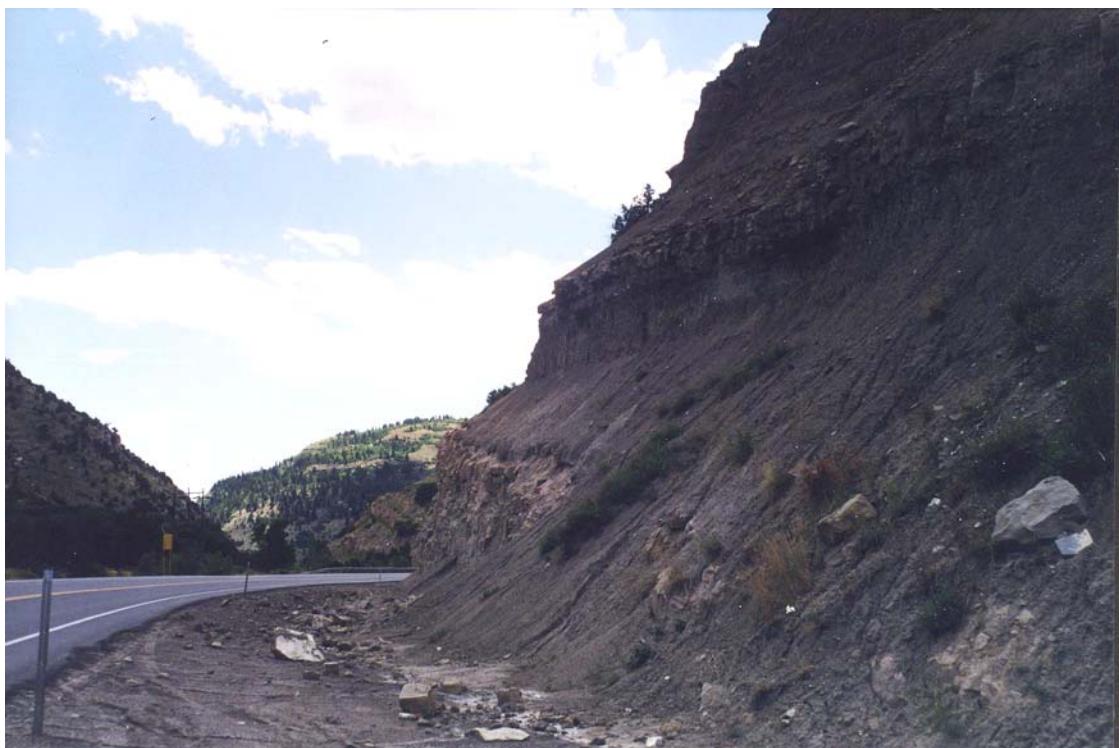
Figure 5. B-rated slope near Colton, Utah.

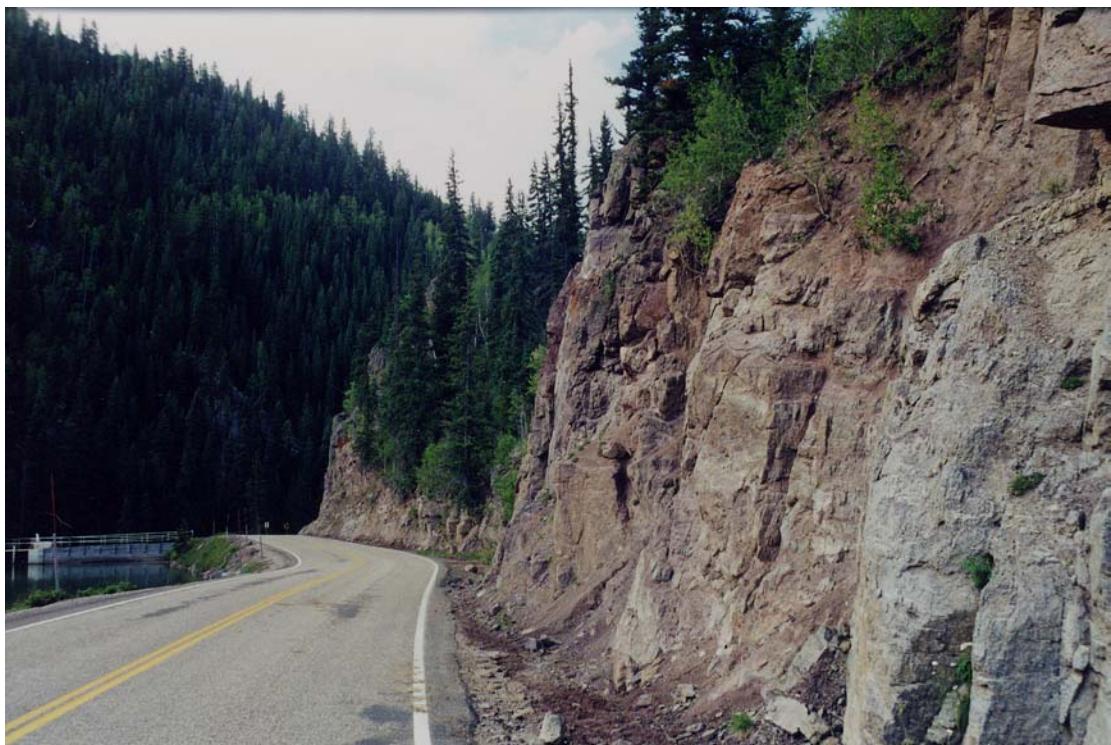
Figure 6 is a typical A-rated slope. This cut located in the Beaver Maintenance Station jurisdiction is a representative A-rated slope for several reasons. The catchment ditch area is inadequate in both width and depth to catch the size material weathered from the rock face. While the face itself is not extremely high and has good cover on top, the sizes of the blocks that are weathering from the cliff face are large and easily capable of reaching the road surface. Final contributing factors to instability on this face evidenced by vegetation are (1) the potential effects of saturation due to relatively high rainfall and (2) the potential effects of seasonal freeze-thaw action during the spring thaw.

Figure 6. Near-vertical A-rated rock cut in the Beaver Maintenance Station.
